NIOSH FIRE FIGHTER FATALITY INVESTIGATION AND PREVENTION PROGRAM

**LINE OF DUTY
DEATH REPORT**

REPORT 2024-01 • April 2025

Volunteer Firefighter Dies when Propane from an Underground Tank
Leaked into a Residential Home causing a Catastrophic Explosion –
Virginia

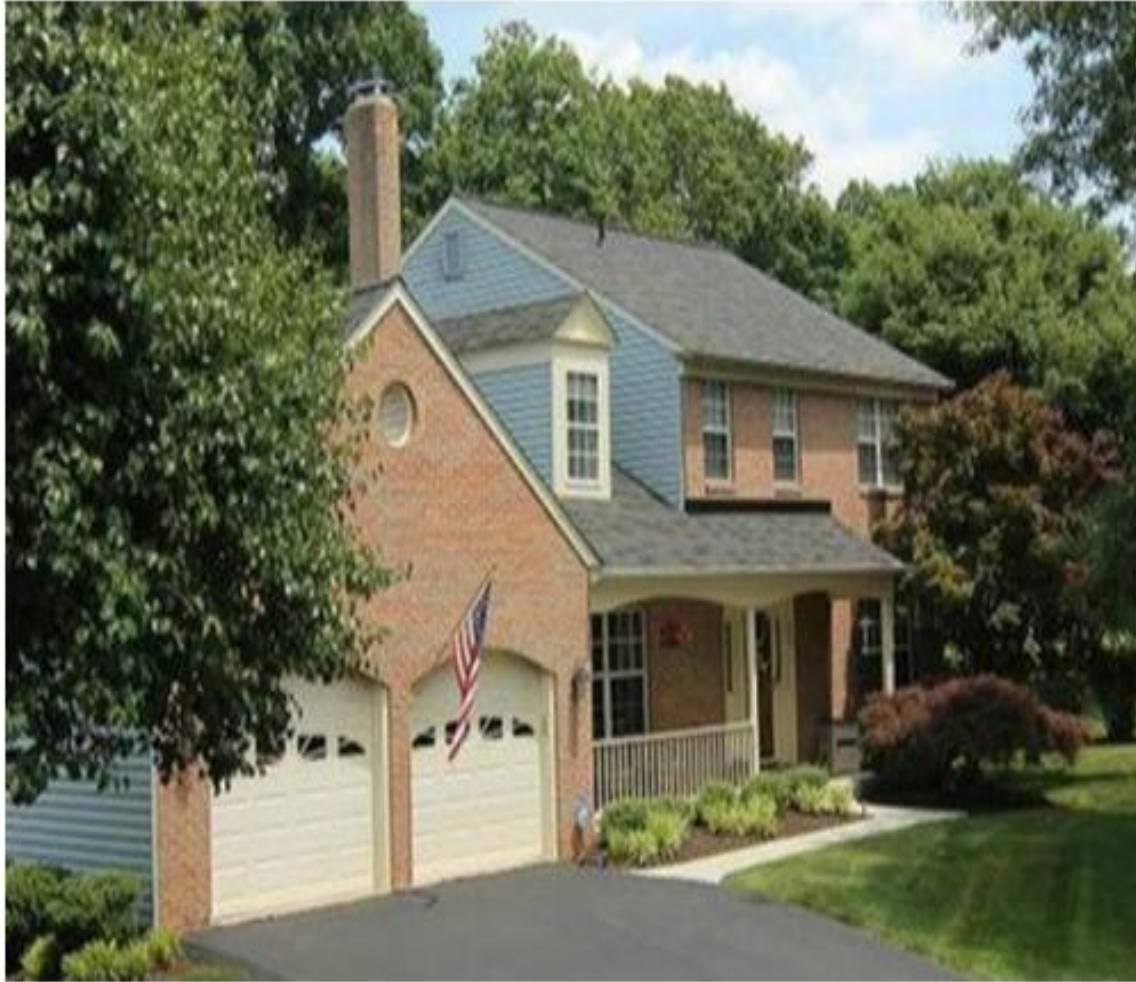
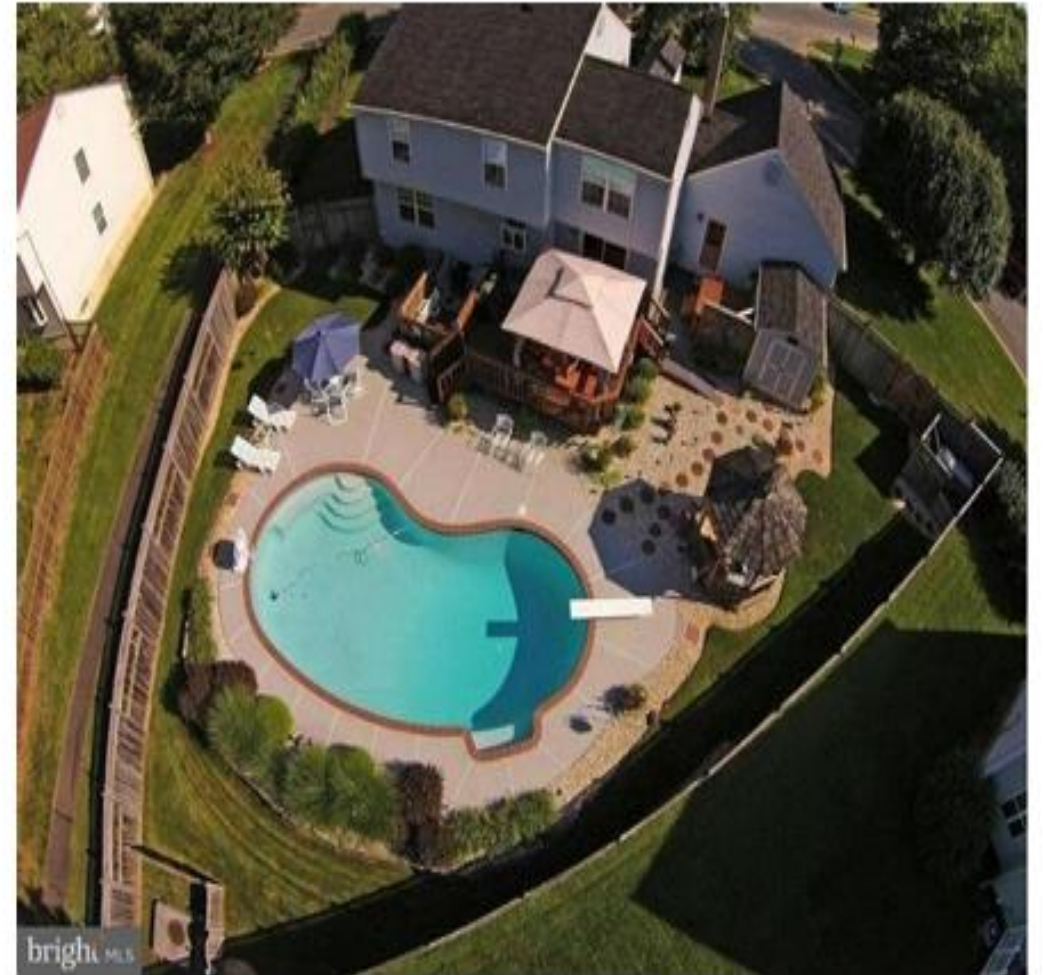
Photo 2 and 3: View of structure pre-incident.
(Courtesy of Fire Marshal's Office)

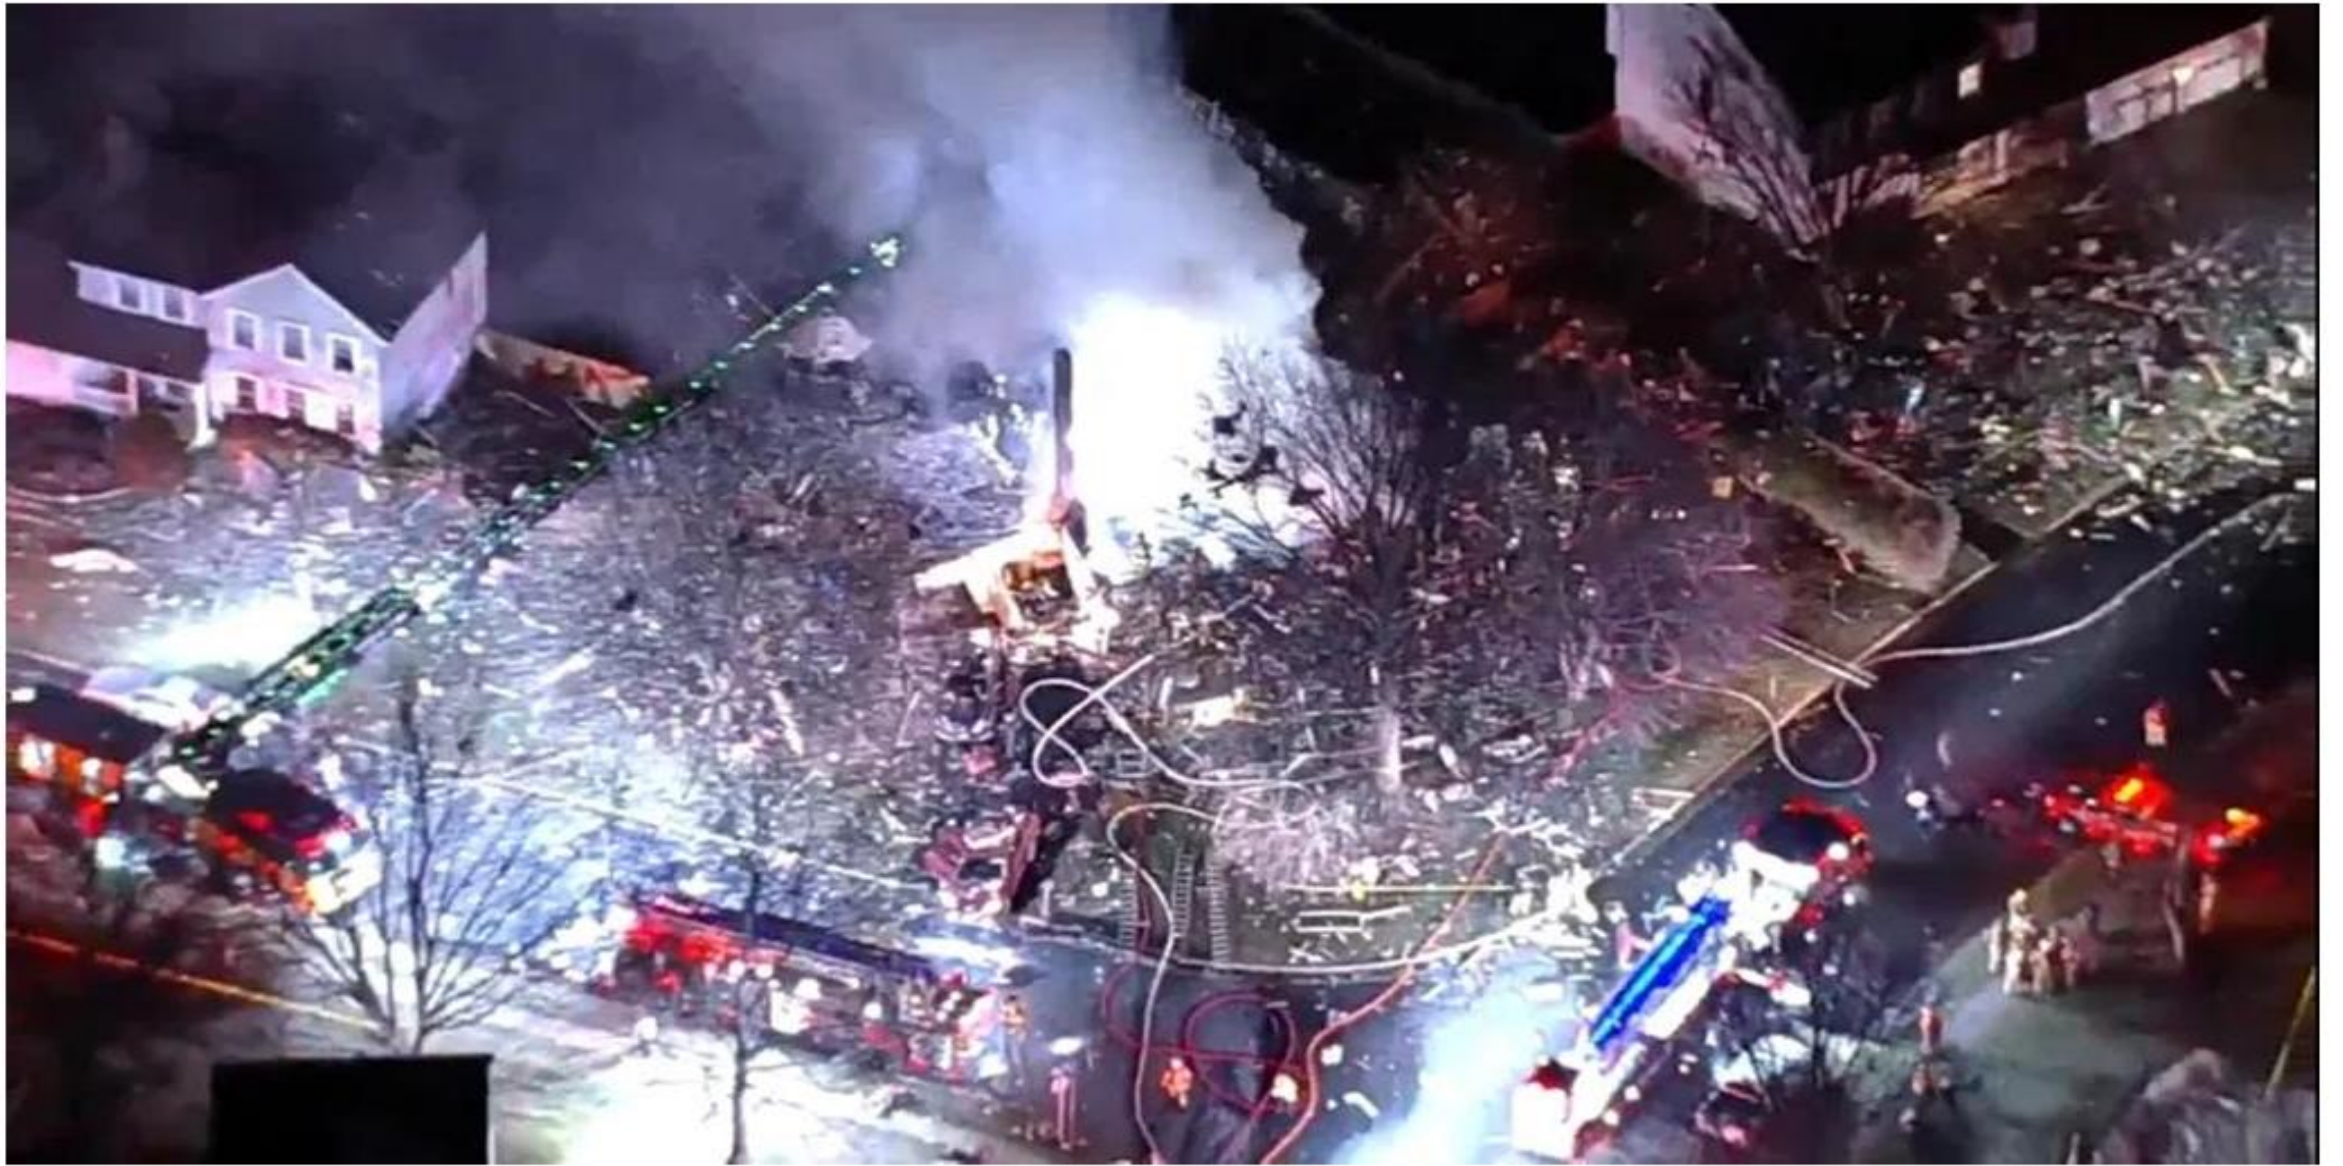
Photo 6: Aerial view of area effected by explosion.
(Courtesy of NBC News)

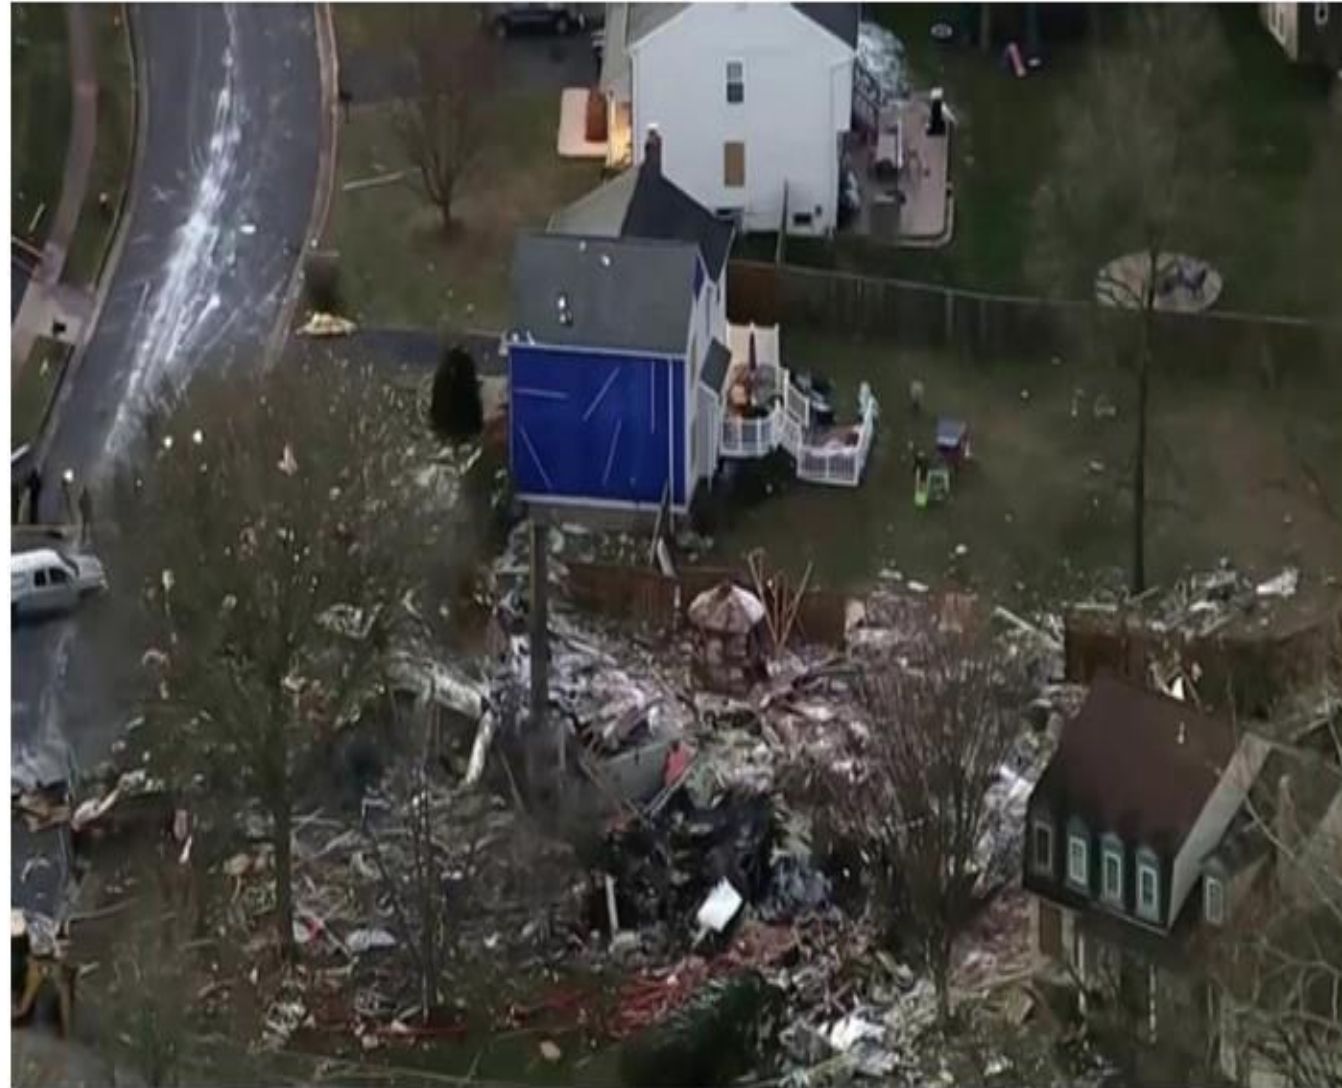
Photo 1: Aerial view of structure and surrounding area post explosion. (Courtesy of fire department)
